Sangamon River at Riverton Reach 2, IL

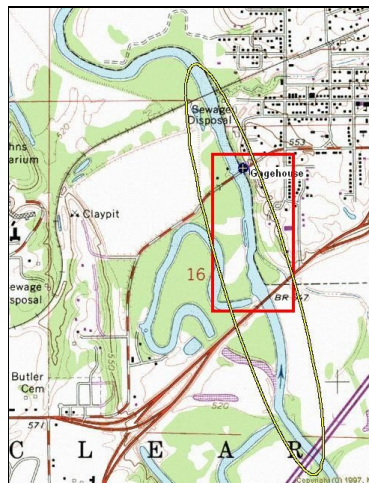
Study Reach.--The channel under consideration is a straight, natural river as shown in quadrangle map on the top left. The selected study reach, 2210 ft long, is located between the downstream side of the Old Route 36 bridge (as upstream) and the upstream site of the abandoned Old River Road bridge (as downstream). Four surveyed cross sections (surveyed by the Illinois Department of Natural Resources, in December 2003) are available for evaluating the channel geometries in the study reach (see plots above). The alignment of the study reach, approximate variations in channel width and bank conditions, and locations of the surveyed cross sections are shown in the aerial photo on the top right.

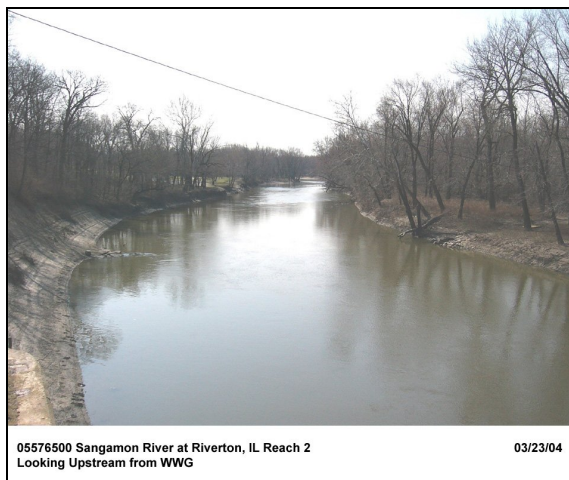
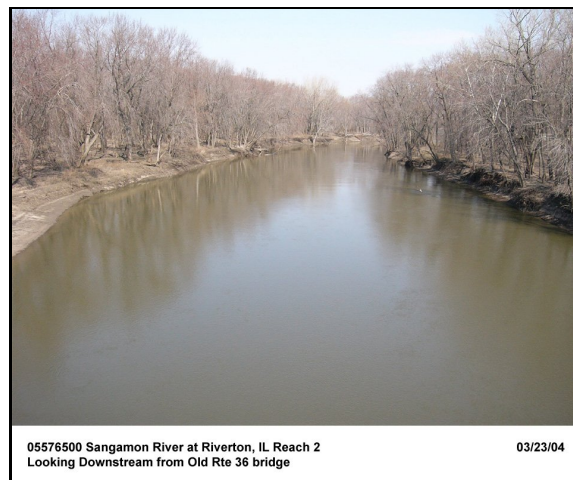
Description of Channel.--This is a natural channel in a straight reach. Bed material consists of sand and gravel. The banks are bare earth, shales, clay, and sand. Cross-sectional geometry is of trapezoidal shape and longitudinal variations are from deeper and wider at upstream to shallower and narrower at downstream. The bottom width ranges from approximately 100 to 150 ft; bank height varies from 16 to 12 ft; and top width of the channel varies approximately from 200 to 250 ft. Sandbars were observed on the relatively flat streambed. The channel has wide flood plains but only in-channel events are used in the study.
